Manhole Inspection Summary

Manhole # S21WW1058MH

Insp Date: **9/11/08 12:40 PM**

Location Address: **CROSS KEYS RD** Cross Street: **HAMLET HILL RD**

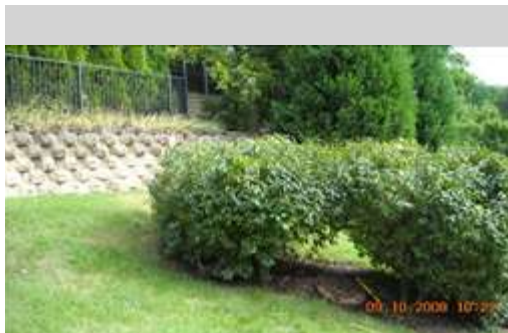
Location View

Comments **REI/DRAYCO VISIT 8/12/08 LOCATED MANHOLE UNDER BUSH.**

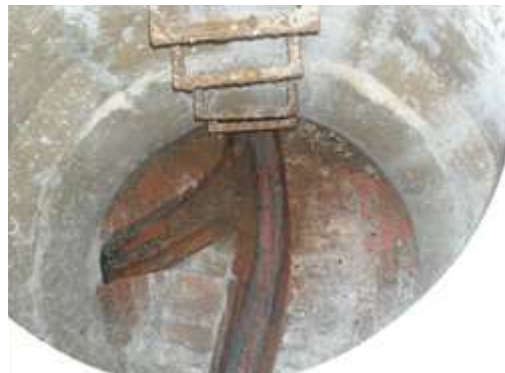
Top View

Bench debris.

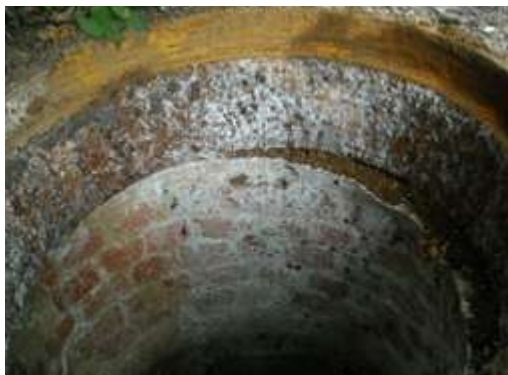
Defect

Frame offset. Corbel infiltration.

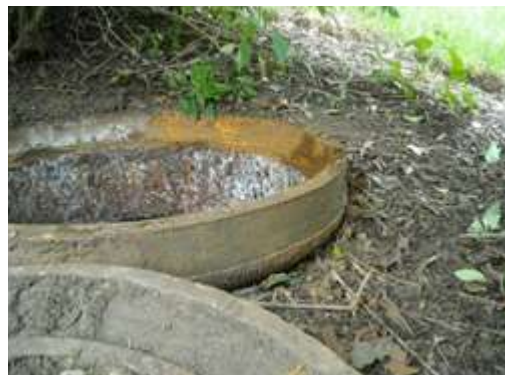
Defect

Above grade.

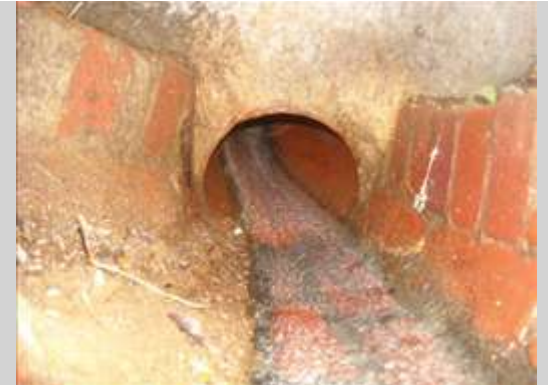
8 in. Circular Gravity Sewer Pipe Out @ 12 O'Clock

Pipe Material: **Clay** ☐ Pipe Lined

Invert Depth: **8.95** (ft.) Flow Characteristics: **Slow**

Infiltration: **None** Pipe Seal Cond: **Unknown**

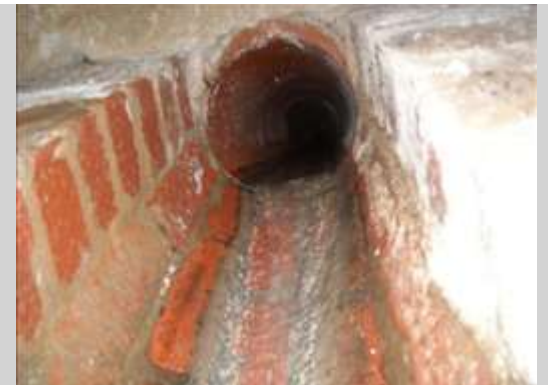
8 in. Circular Gravity Sewer Pipe In @ 7 O'Clock

Pipe Material: **Clay** ☐ Pipe Lined

Invert Depth: **7.55** (ft.) Flow Characteristics: **Slow**

Infiltration: **None** Pipe Seal Cond: **Unknown**

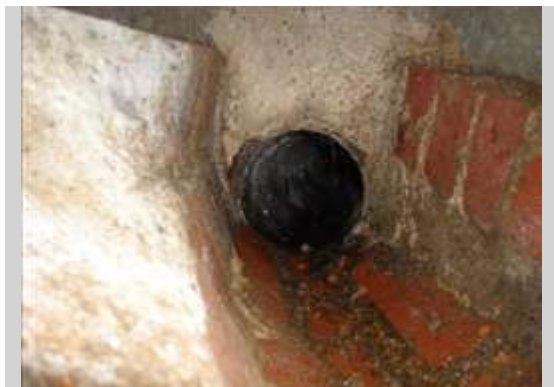
6 in. Circular Gravity Sewer

Pipe Material: **Clay**

Invert Depth: **8.10** (ft.) Flow Characteristics: **Slow**

Infiltration: **Evidence**

Connects To: **House connection / Service line**
